John F. Kennedy Space Center, FL Hurricane Frances Damage Assessment Photos

John F. Kennedy Space Center Hurricane Frances Damage Assessment Photos

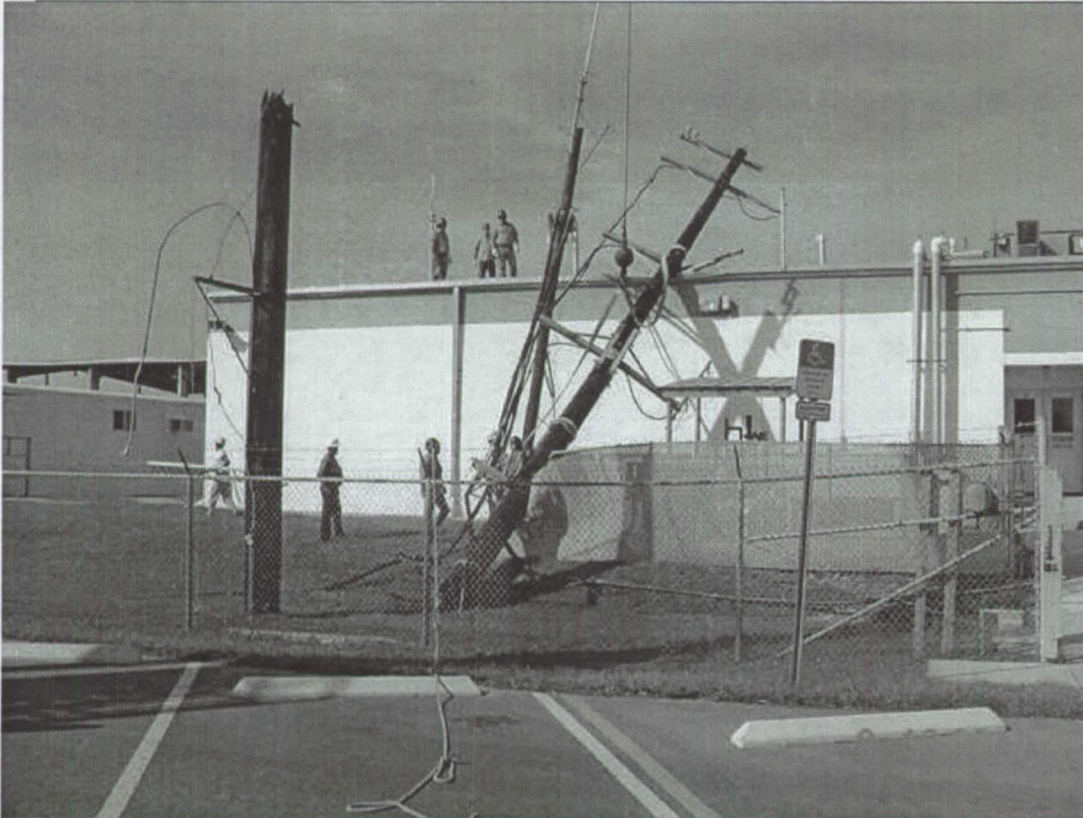
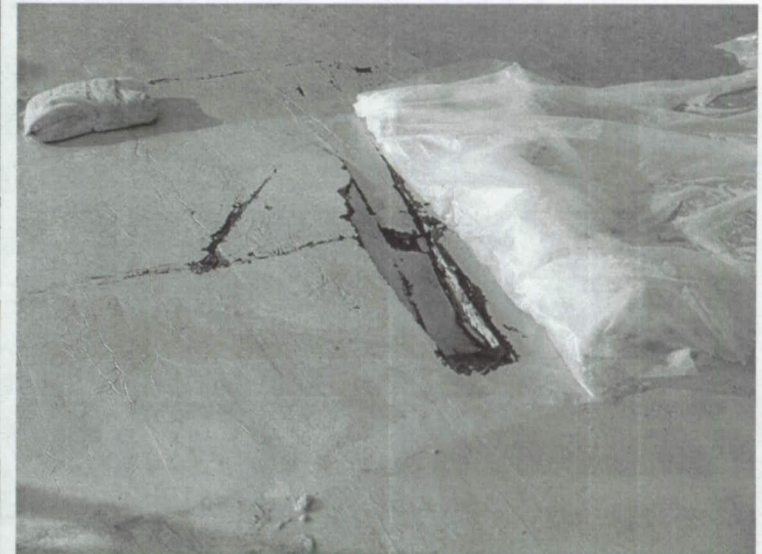
Shuttle Landing Facility

Landing Aids Control Building (J6-2313) – power/communications pole
damage, exterior roof damage
